U. S. STEEL MINNTAC
TWIN LAKES WILD RICE RESTORATION
OPPORTUNITIES PLAN
2015 ANNUAL REPORT

DECEMBER 31, 2015

PREPARED BY
NORTHEAST TECHNICAL SERVICES, INC.
526 CHESTNUT STREET
Virginia, MN 55792

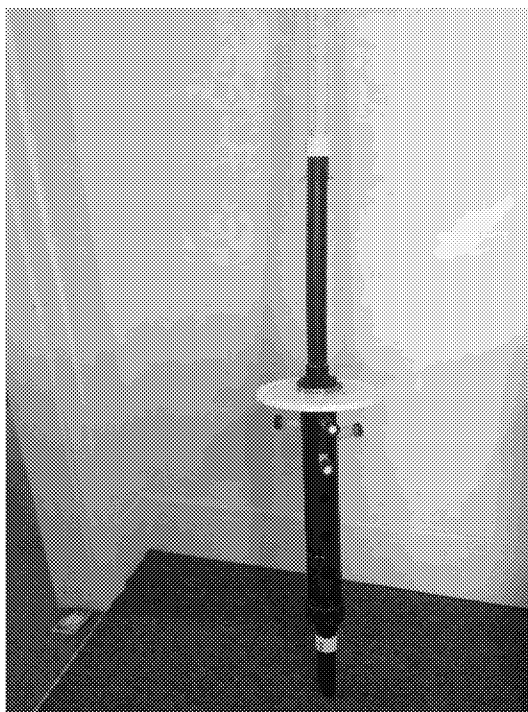
Image 1. Peeper sediment pore water sampling device.

Peepers (as pictured above) were deployed with sealed 50 mL centrifuge tubes within the top 10 cm of sediment. Each 50 mL centrifuge tube was completely filled (no headspace) with deionized water obtained from Pace Analytical Laboratories (Pace; Virginia, MN); this is the type of purified water Pace uses for formulating their analytical standards, and periodic 'blank' samples. Each tube contained a 0.45 μM pore size filter in the cap to allow for deionized water / pore water equilibration via diffusion. Using peepers to collect pore water samples for characterization can better minimize, if not eliminate, the potential for the collected pore water to be exposed to air / oxygen.

A more effective and defensible method of sediment pore water sampling and characterization is through the use of peeper style samplers (see **Image 1** below). Six peepers were deployed during the 2015 field season; four in Little Sandy Lake and two in Sandy Lake (see **Figure 1**). Deployment locations were chosen due to measured concentrations of sulfide above the reporting limit from sediment core samples obtained during 2013 and 2014; and for their representativeness of the Twin Lakes inflows, outflow, and middle areas. Peepers were deployed for three, (approx.) 30-day durations between July – August, August – September, and September – October; and were re-deployed immediately following removal of the sample tubes, and replacement of new sample tubes, after each respective 30-day deployment duration. The first set of 50 mL centrifuge tubes containing peeper samples were sealed using parafilm, and stored and transported on ice to Dr. Peter Lee for analysis at Lakehead University Environmental Laboratory (LUEL). The second and third set of peeper samples were treated as follows: two of the four, 50 mL volumes of sample were poured into a sodium hydroxide / zinc acetate preserved bottle for sulfide measurement (100 mL total). This was done in an effort to minimize exposure of the pore water samples to ambient atmosphere prior to preservation. The remaining two, 50 mL samples were sealed. All samples were stored and transported on ice to Dr. Lee for analysis at LUEL.

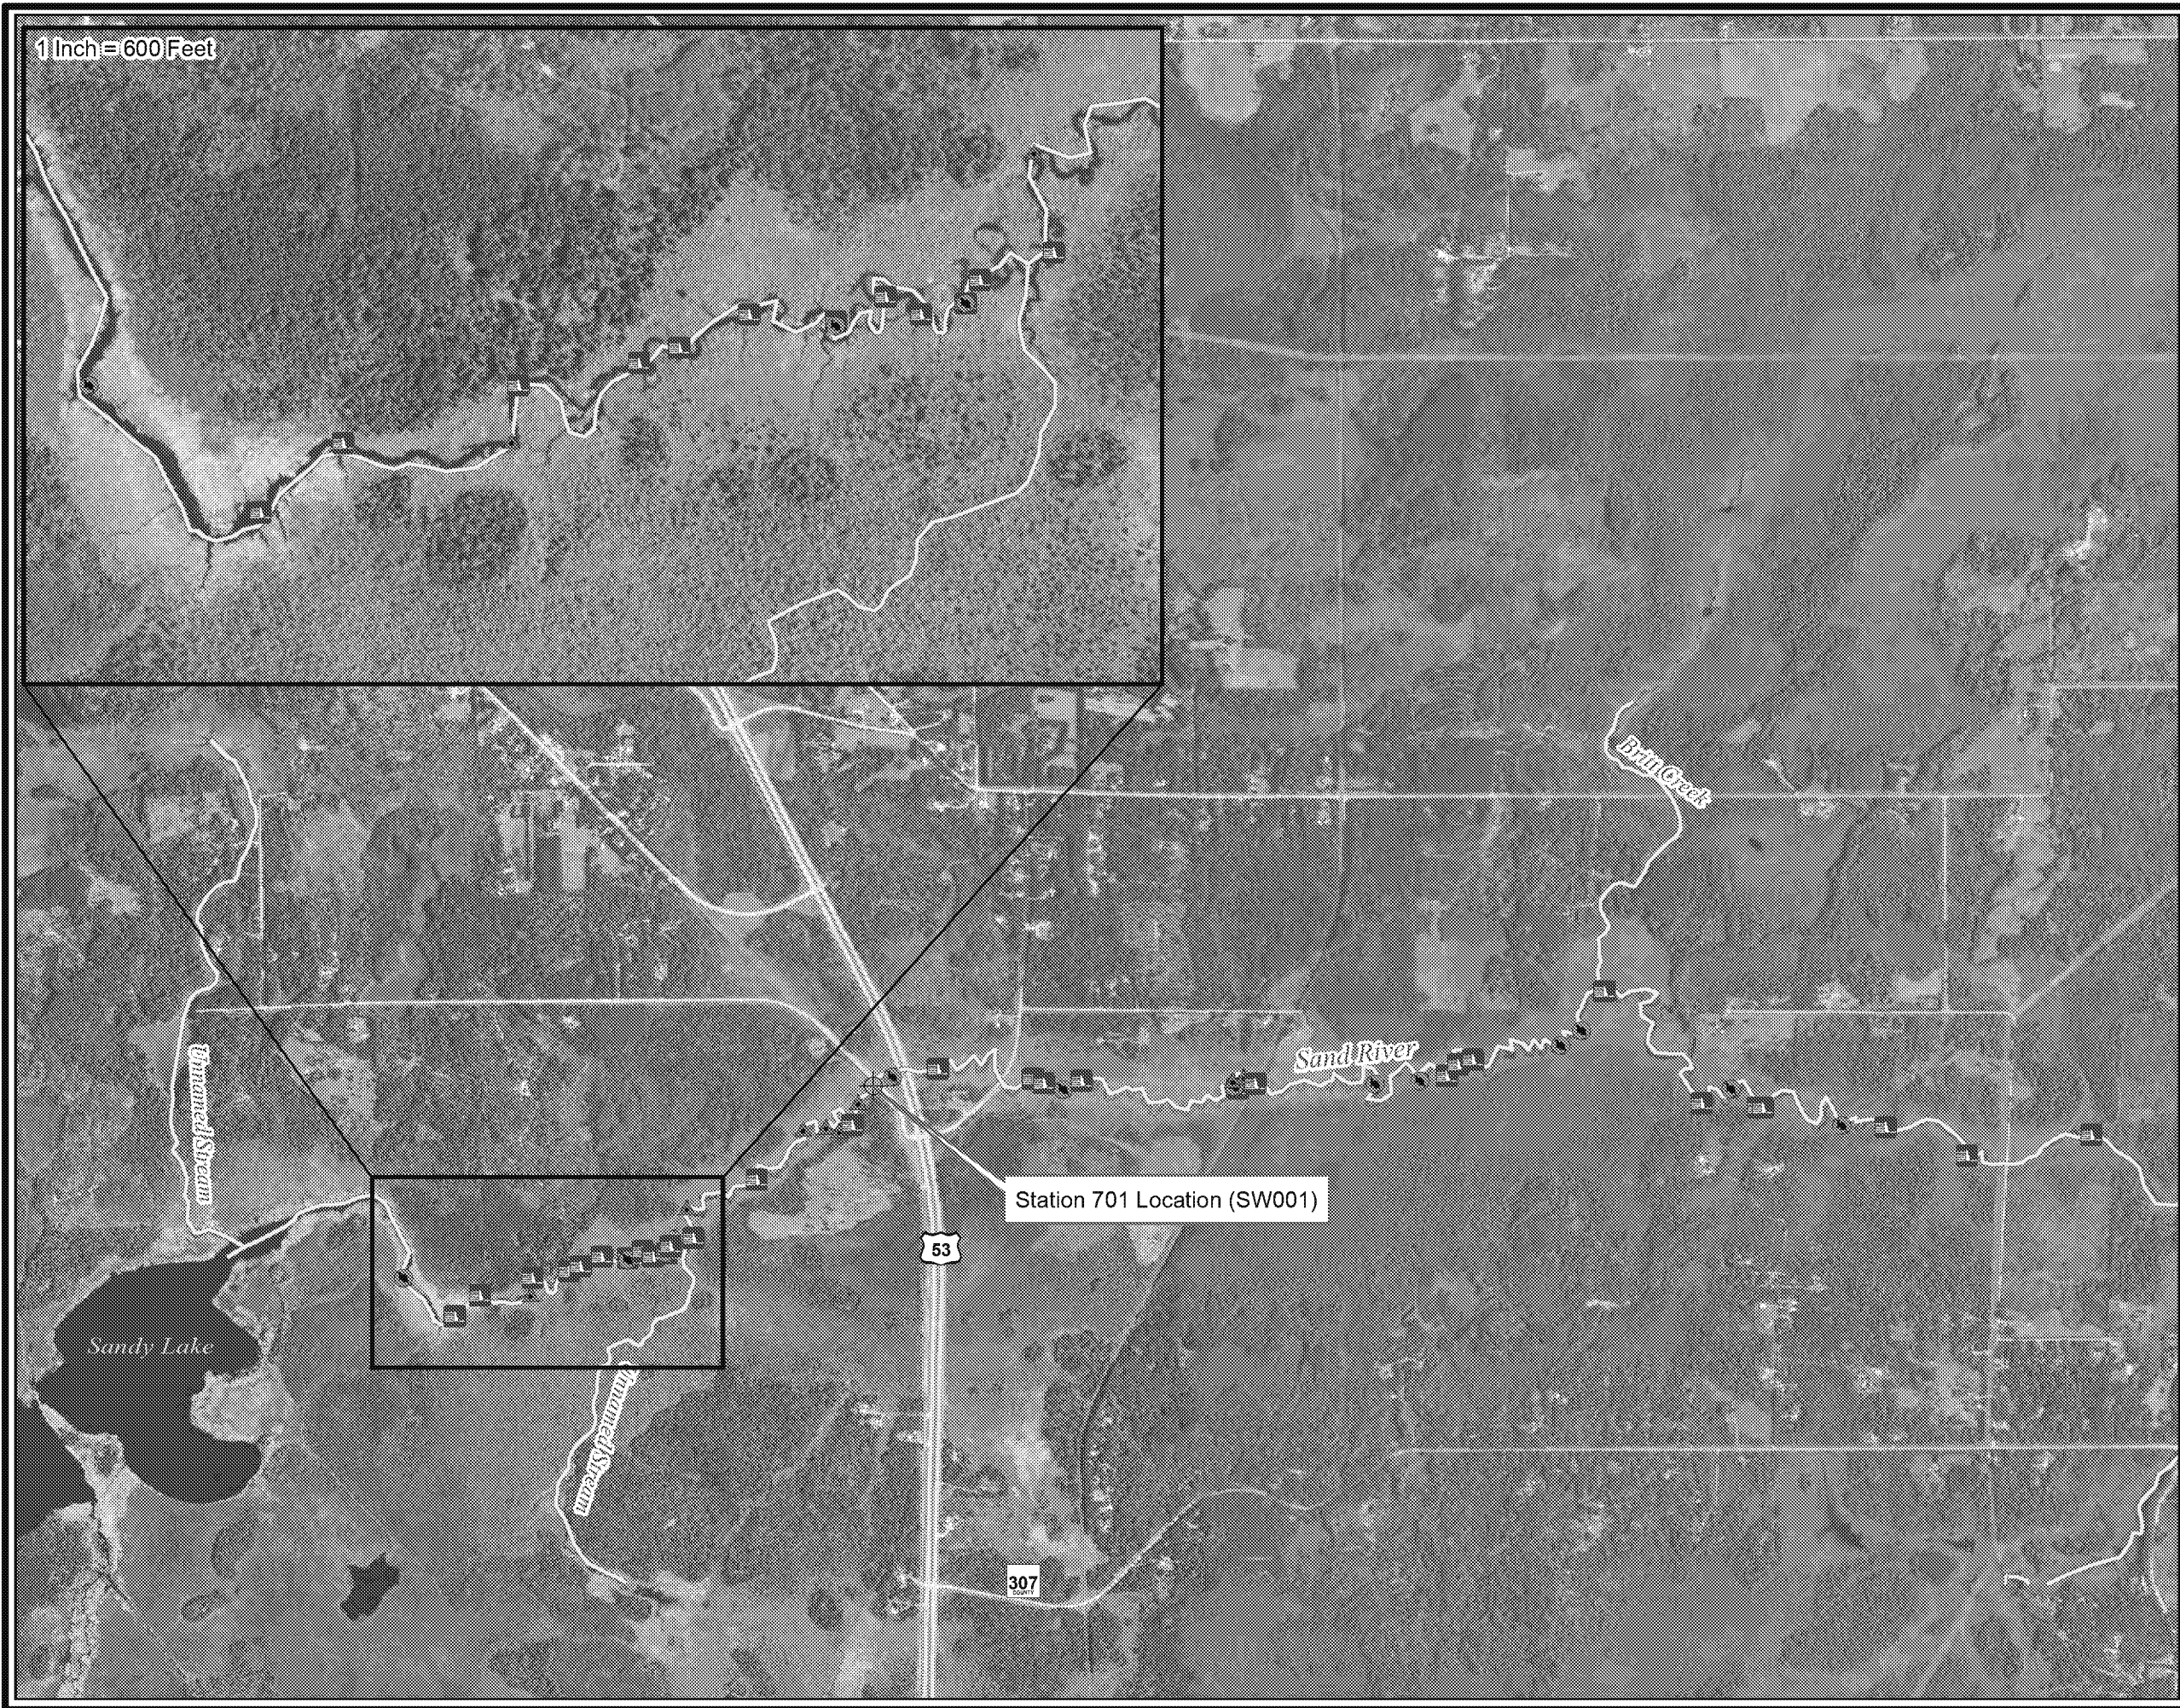
- Beaver Lodge
- Beaver Dam
- Riffle
- Sand River

Comment noted. **Figure 7** (Sand River Beaver Activity Survey Map) provides the location of the Station 701 monitoring location, i.e., upstream (west) side of box culvert under County Road 306, immediately upstream of U.S. Hwy 53.

A separate survey of the Sand River downstream of Sandy Lake was conducted by U. S. Steel and NTS personnel on June 21 to evaluate the presence of beaver dams and pinch points within the Sand River channel. **Figure 7** shows the location of channel obstructions from the June 21 survey. The majority of the channel obstructions were responsible for only small increases in water level immediately upstream. However, in aggregate, the old beaver dams and associated channel debris are causing water levels to be held up in the system, especially after significant rainfall events, as evidenced by the pressure transducer data from the steel bridge. It will be difficult to maintain water levels in the Twin Lakes at optimum depths for consistent wild rice growth given the large number of relic dams and pinch points currently present in the Sand River channel between Sandy Lake and U.S. Hwy 53. It is recommended that the Sand River channel be cleared of some of the more troublesome stretches of submerged woody debris to reduce the amplitude and duration of the “bounce” within the Twin Lakes from runoff after significant rainfall events.

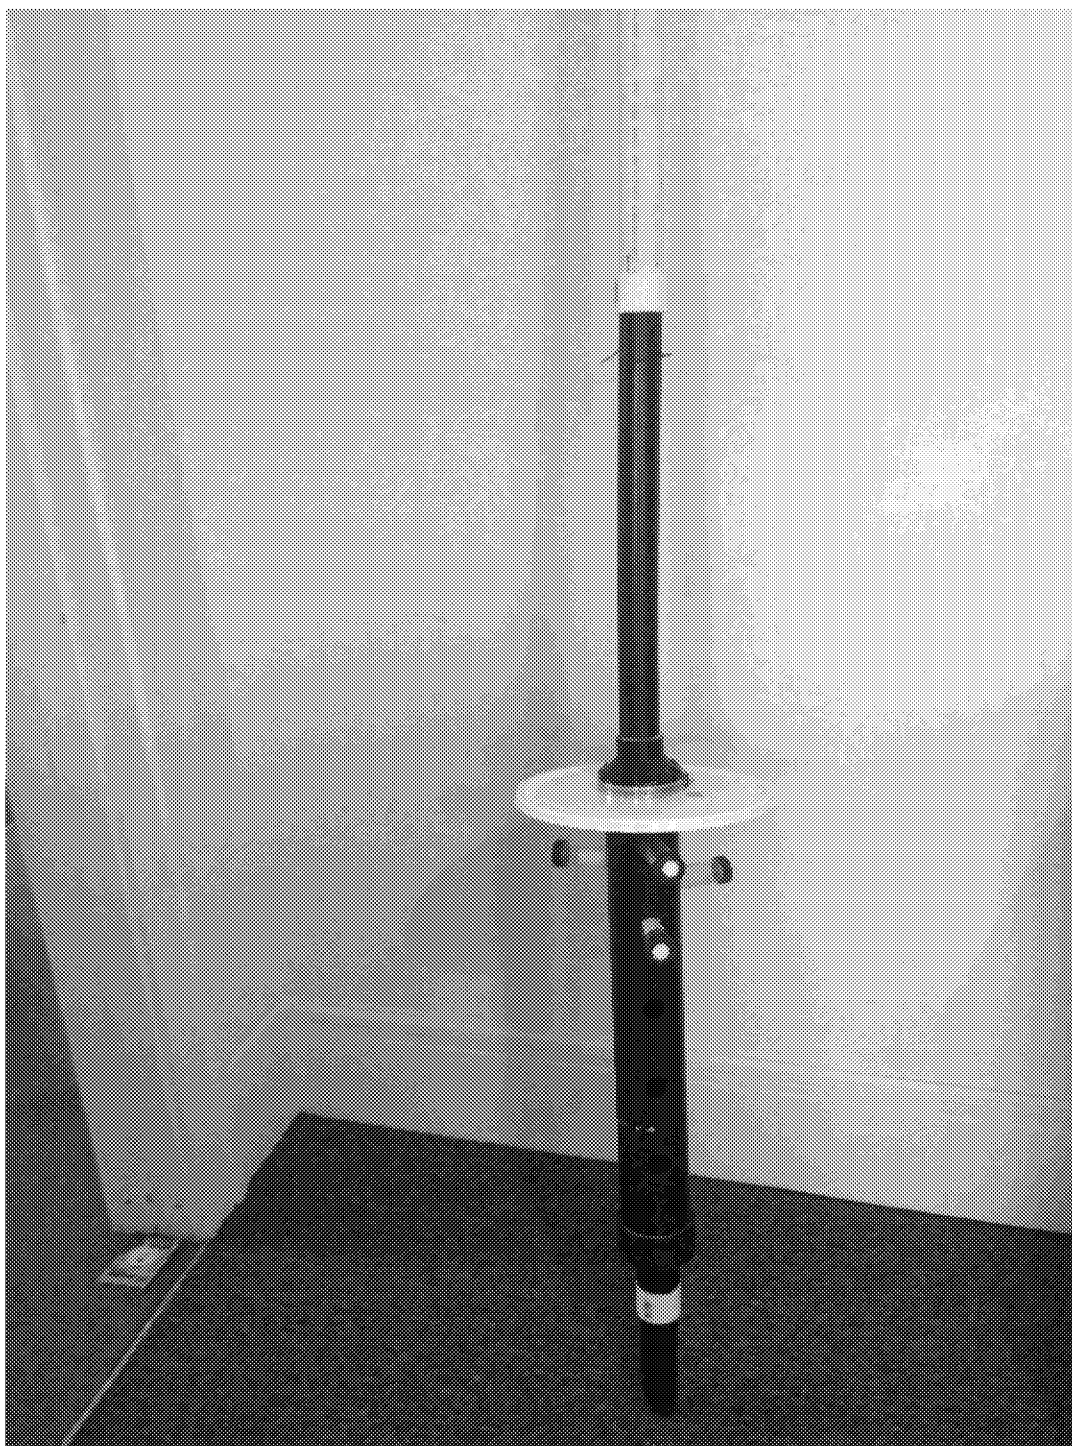
Sediment pore water sampling device ('peeper'). The white 'bucket lid' is positioned to sit on top of the sediment, allowing submersion of the four, 50 mL centrifuge tubes within the top 10 cm of sediment.

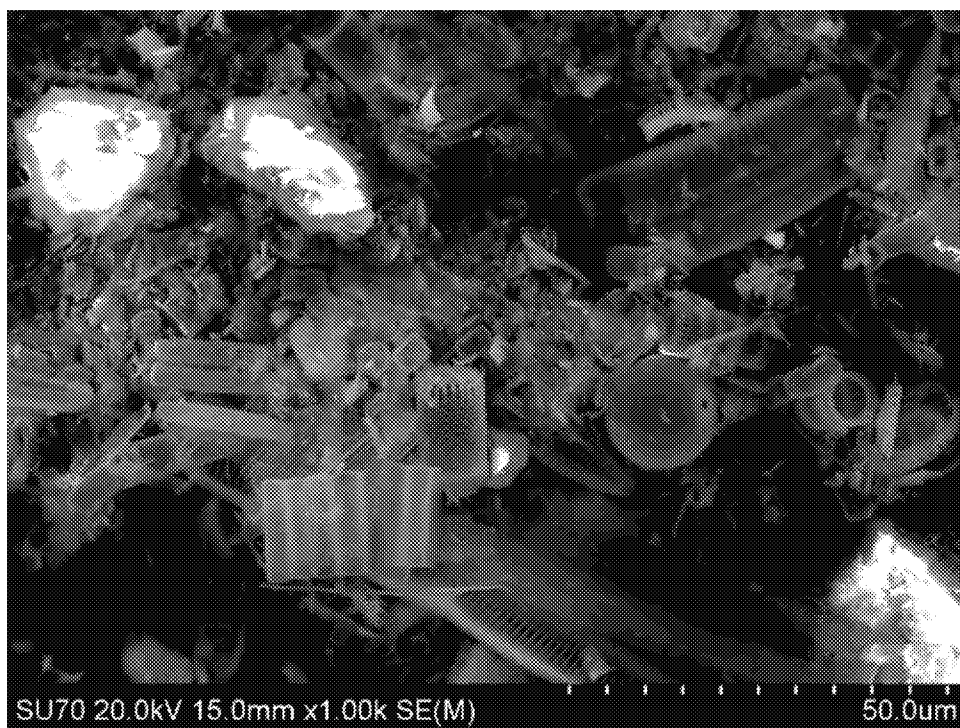
Pollen grain image from Sandy Lake sediment core - SL1 location.

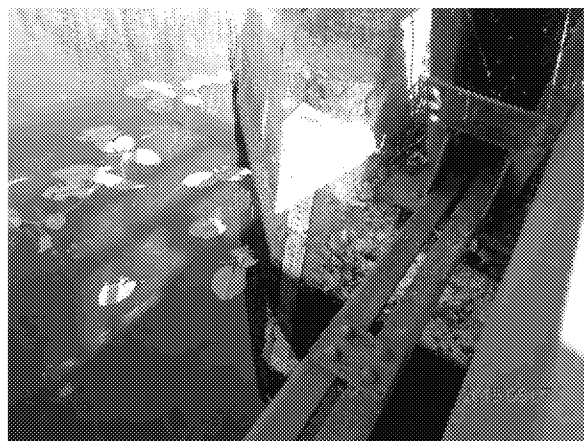
Staff Gauge located on Steel Bridge
